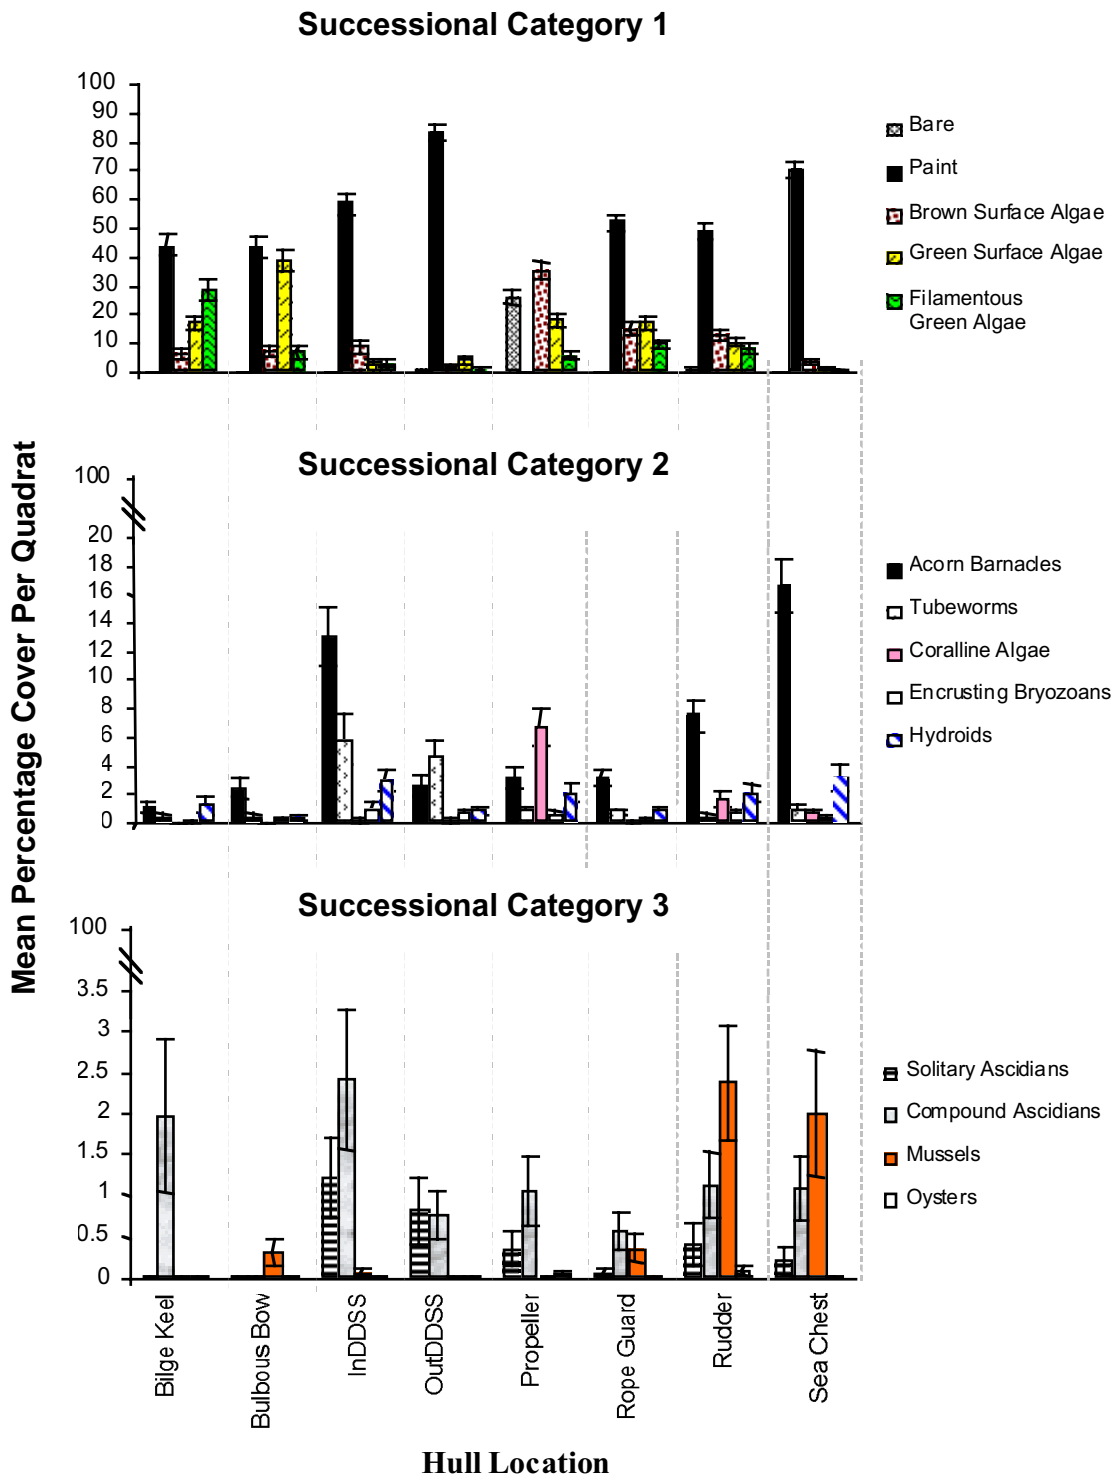
**Figure 1.** Percentage cover of fouling organisms on different parts of the hull within each of three successional categories, as determined by analyses of video footage taken for hull inspections of merchant vessels visiting New Zealand. Values are means  $\pm$  1. SE.
